SANITARY SEWER LINE REPLACEMENT IN WOLF CREEK

INFRASTRUCTURE CONDITION

PROJECT PHOTOGRAPHS

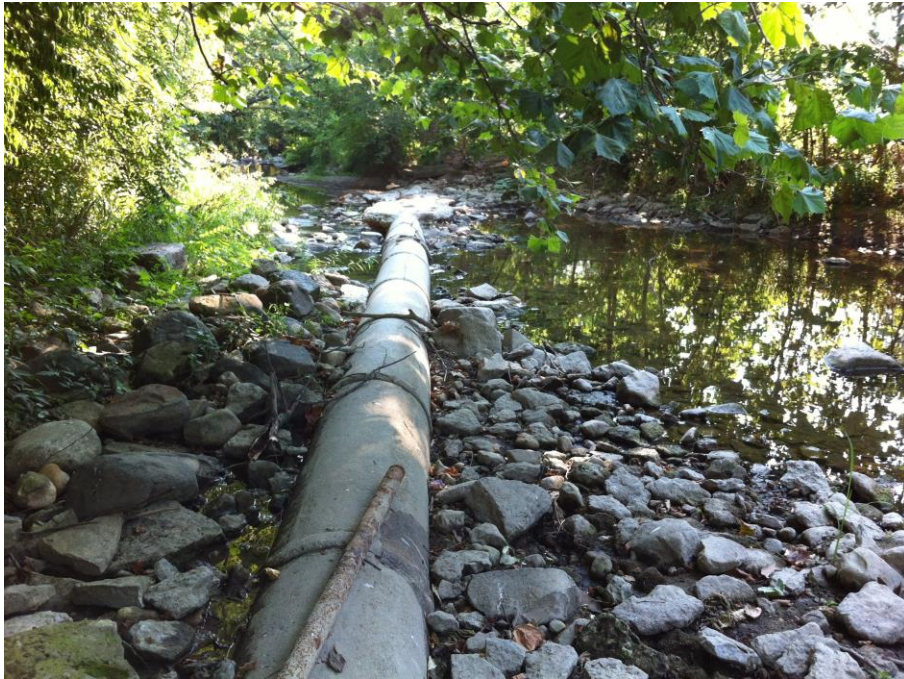
Picture shows the 18" diameter trunk sewer exposed in Wolf Creek (looking east).

This project will eliminate 3 creek crossings. One crossing, the sanitary sewer has been exposed by erosion of the creek bed. This has led to the sewer line cracking and letting raw sewage seep into Wolf Creek. The other two crossings are not far behind this one in being exposed. This project will also eliminate an inverted syphon that, at times, has gone septic due to low flows, causing both a health and odor problem

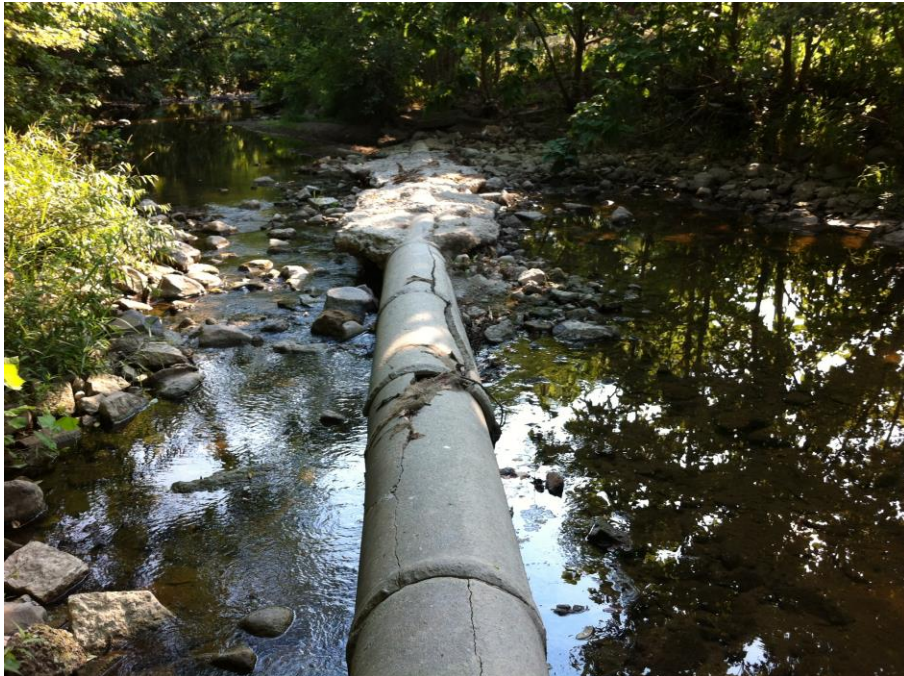
Picture shows cracked 18" diameter trunk sewer exposed in Wolf Creek (looking east).

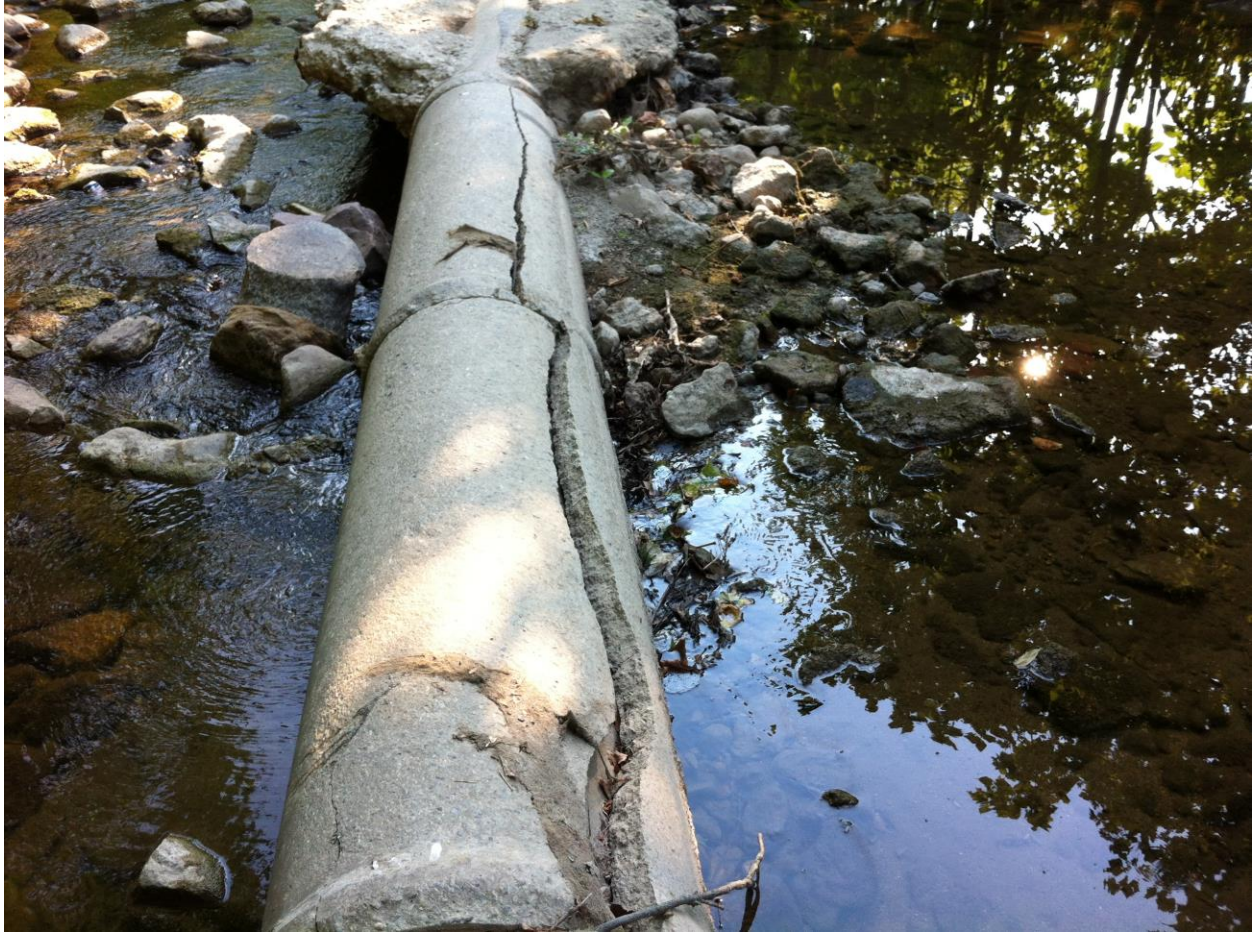
The original useful life of the collection system was 50 years. It is currently 65 years old. The original function was to follow the Wolf Creek and to cross it at several points; however, over the years the flow has eroded the creek bed and exposed the pipe. The elements have cracked the pipe causing it to leak raw sewage into Wolf Creek. The work is needed to eliminate the creek crossing in the project area to insure the health and safety of the resident that live along Wolf Creek.

Picture shows detail of the cracked 18" diameter trunk sewer exposed in Wolf Creek (looking east).
